Cold Spray Aluminum for Magnesium Gearbox Repair

Phillip F. Leyman
US Army Research Laboratory
Weapons & Materials Research Directorate

SERDP/ESTCP Surface Finishing Workshop
February 26-28, 2008

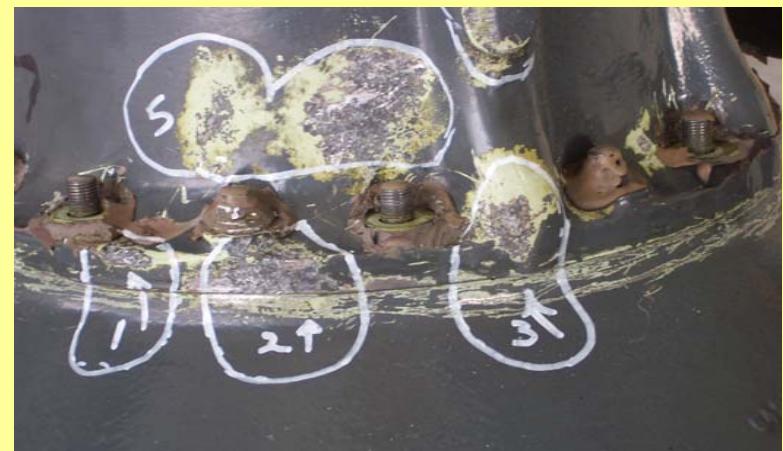
Corrosion on H-53 Tail Gearbox Housing

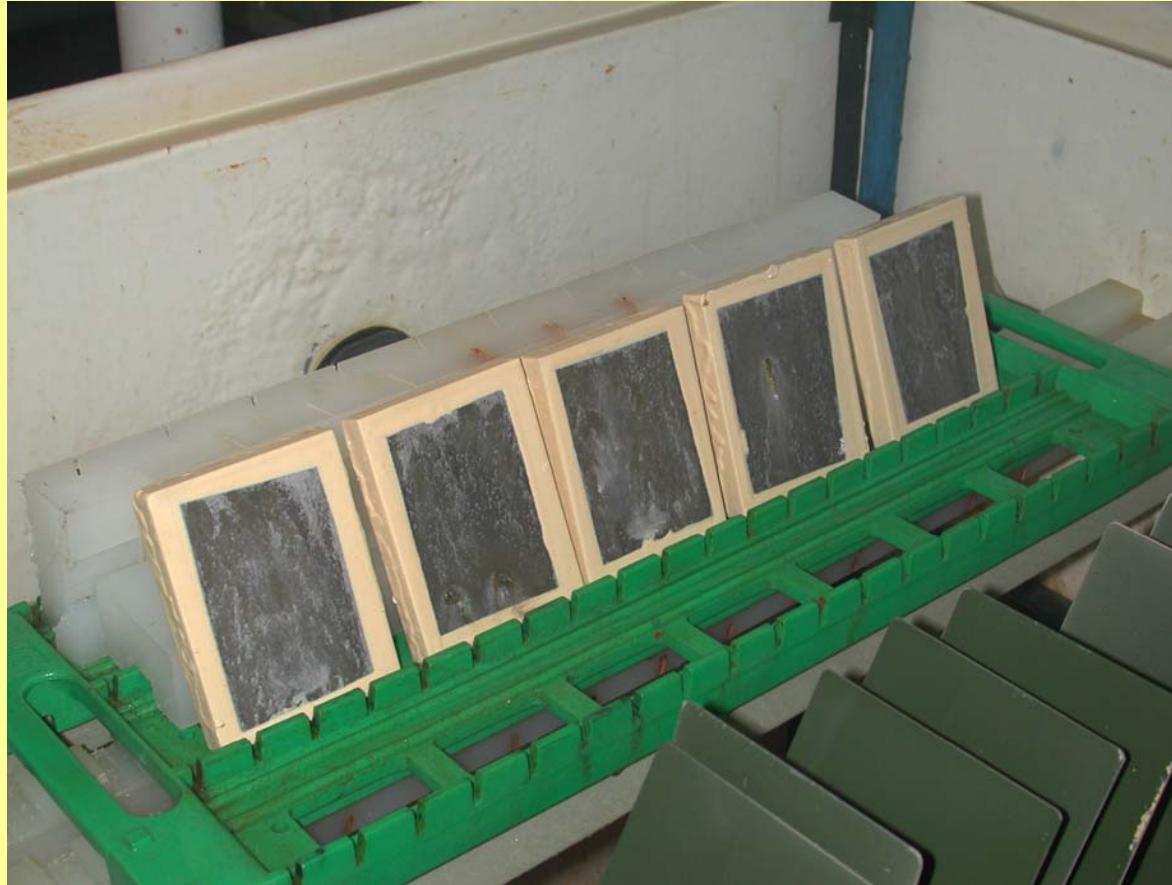
Aluminum coated ZE41A Magnesium (8 Hours in Salt Spray)

<i>Process Conditions</i>	<i>Nozzle Powder</i>	<i>Adhesion (psi)</i>	<i>Corrosion Results</i>
N2, 380psi, 250C	Metal 15- 45 um	2743	8 hrs
He, 380psi, 20C	Metal 15- 45 um	>8,505 (glue failure)	>500 hrs*
N2, 380psi, 300C	Metal/Plastic 7-28 um	4764-5985	1000 hrs
N2, 380psi, 400C	Plastic 7-28 um	>10,350 (glue failure)	>2,400 hrs*

Cold Spray Aluminum deposited using N₂ Gas at 250 °C

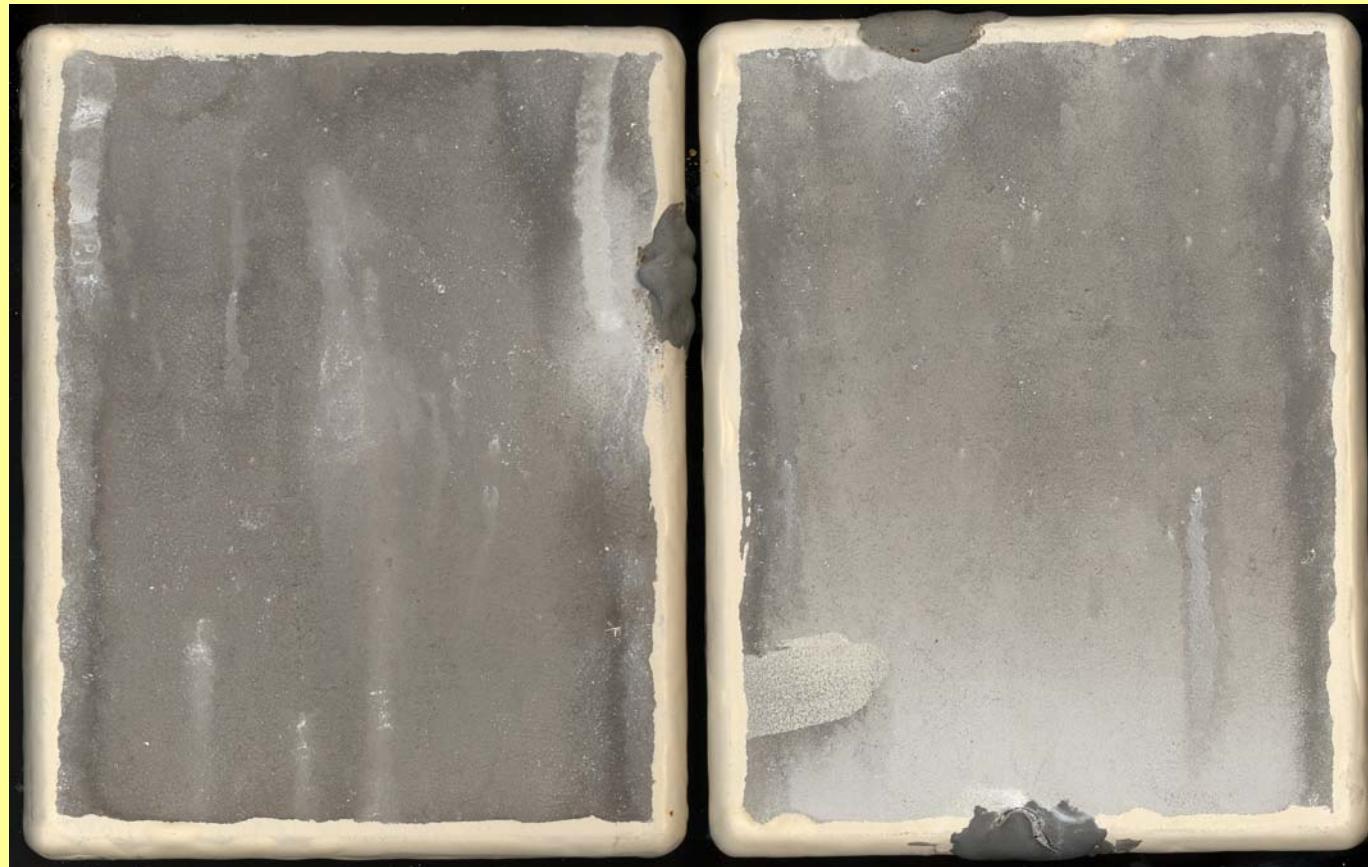
Aluminum Cold Spray Coated Magnesium Coupons After Salt Spray Exposure

2400 Hours Exposure (.5mm)

2400 Hours Exposure (1mm)

Cold Spray Aluminum deposited using N₂ Gas @ 400 °C

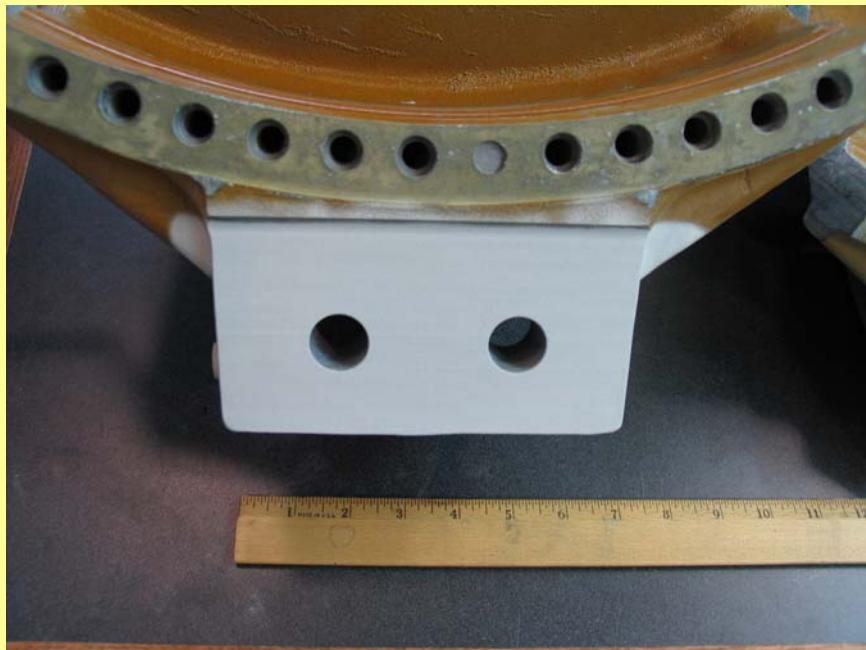
Mg Housing Coated with CP-Al

Flat surface of Mg housing covered with CP-AL Cold Spray
